**MATERIAL SUPLEMENTAR 1:** Séries temporais de imagens registradas no CoastSnap em Conde-PB

## Aplicação CoastSnap para proposta de monitoramento cidadão em ecossistemas costeiros-marinhos no domínio da Mata Atlântica: caso no município do Conde – Paraíba

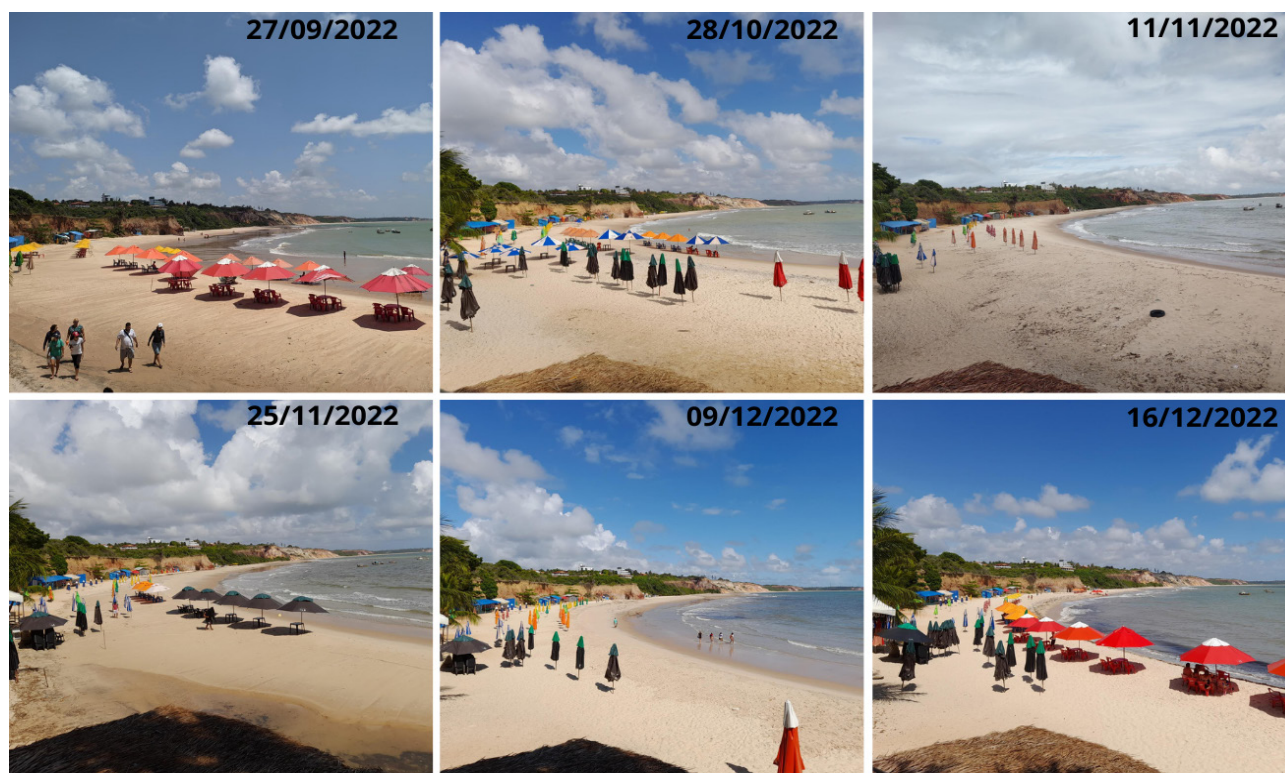
A Figura 1, demonstra uma série temporal na praia do Amor, a partir dessa linha do tempo foi possível analisar essas mudanças ao longo dos meses do projeto.

Uma mudança interessante que se pode analisar foi em relação a erosão da linha de praia, do dia 09/12 ao dia 16/12 devido às ações das ondas em maré alta

**FIGURA 1:** Linha do tempo da Praia do Amor, imagens capturadas de setembro a dezembro de 2022. Autodescrição: sequência de fotografias de uma praia (chamada Praia do Amor)

houve a formação de uma escarpa praial, como um “degrau”, esse tipo de feição ocorre com frequência nessa praia, o interessante seria uma quantidade maior de fotos ao longo do tempo para acompanhar os avanços da formação dessas escarpas.

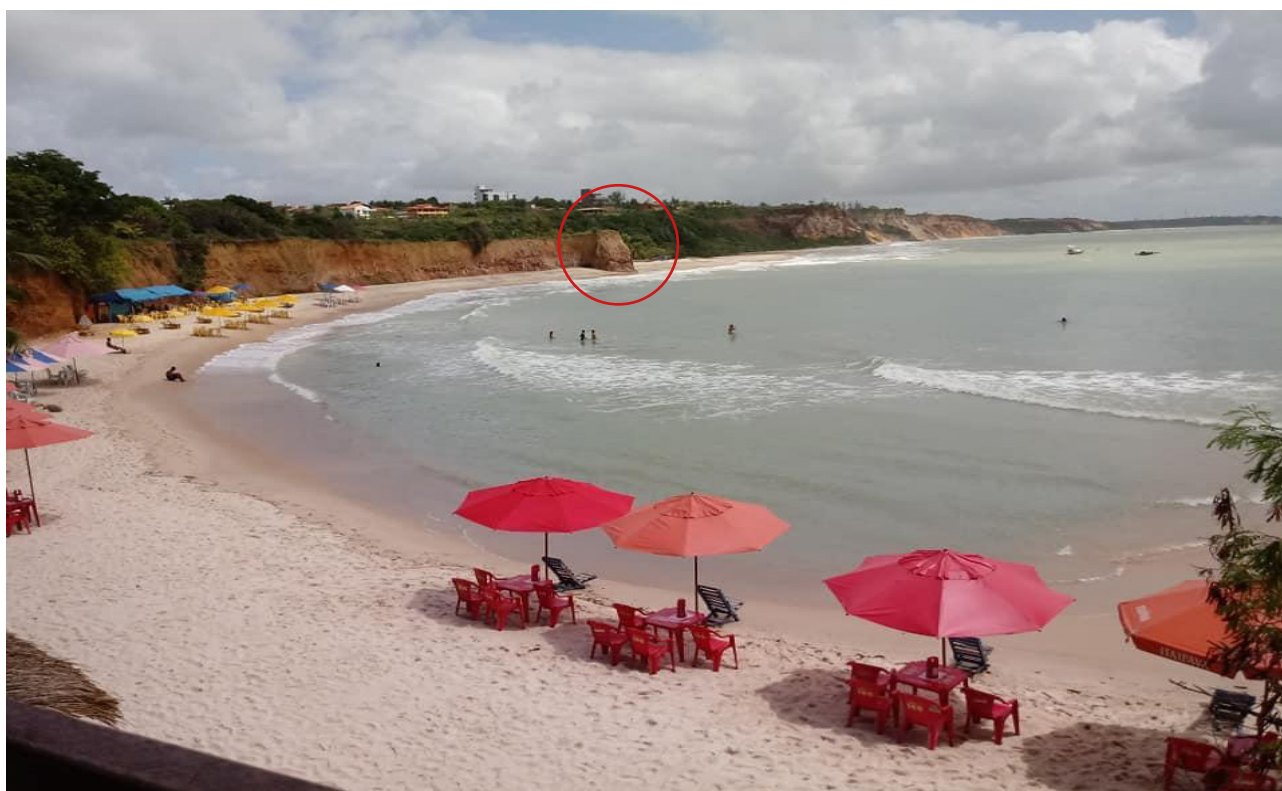
Uma cavidade formada na falésia no final dessa porção da praia chama atenção, essa erosão é causada pela alta maré que atinge a falésia erodindo e formando um buraco nessa feição. Relatos de moradores locais nos informaram que essa ponta da falésia era maior em sentido para o mar e que outra cavidade já havia sido formada anos atrás e com o tempo foi

totalmente erodida e agora esta seria uma nova cavidade que está aumentando gradativamente. Esse é um ponto muito relevante que pode ser observado ao longo do tempo pelo app CoastSnap, no período de desenvolvimento deste projeto (6 meses) não foi possível observar uma mudança perceptível nesta cavidade, mas se observarmos uma fotografia registrada e publicada pelo restaurante Cantinho do Amor nas redes sociais em 2019 na Figura 2, podemos observar que houve mudanças na abertura dessa cavidade em relação a dezembro de 2022 (Figura 3), num período de aproximadamente 4 anos.

**FIGURA2:** Praia do amor em 2019, com destaque para cavidade na ponta da falésia. Fonte: Cantinho do Amor (Facebook). Disponível em: <https://www.facebook.com/photo/?fbid=1647812958698925&set=pb.100039534506013.-2207520000>. Acesso em : 25/01/2023. Autodescrição: foto faixa de areia de praia com sinalização de erosão costeira.

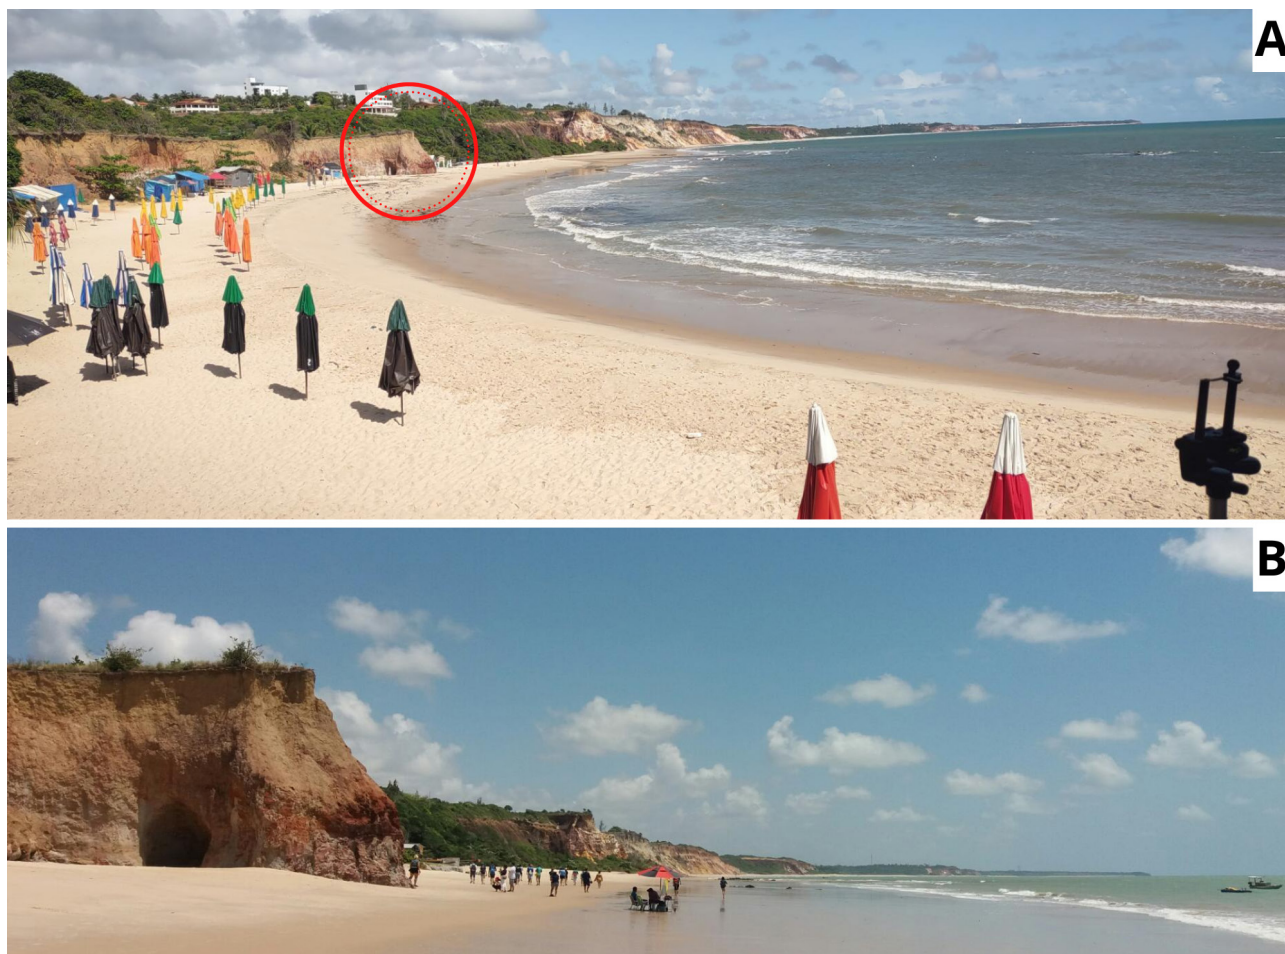
**FIGURA 3:** Praia do amor em 2022, destaque para abertura da cavidade na ponta da falésia. A) Foto tirada pelo app CoastSnap durante uma ação de monitoramento. B) Foto próxima da cavidade, observa-se proximidade com a linha da costa. Autodescrição: foto faixa de areia de praia com sinalização de erosão costeira.

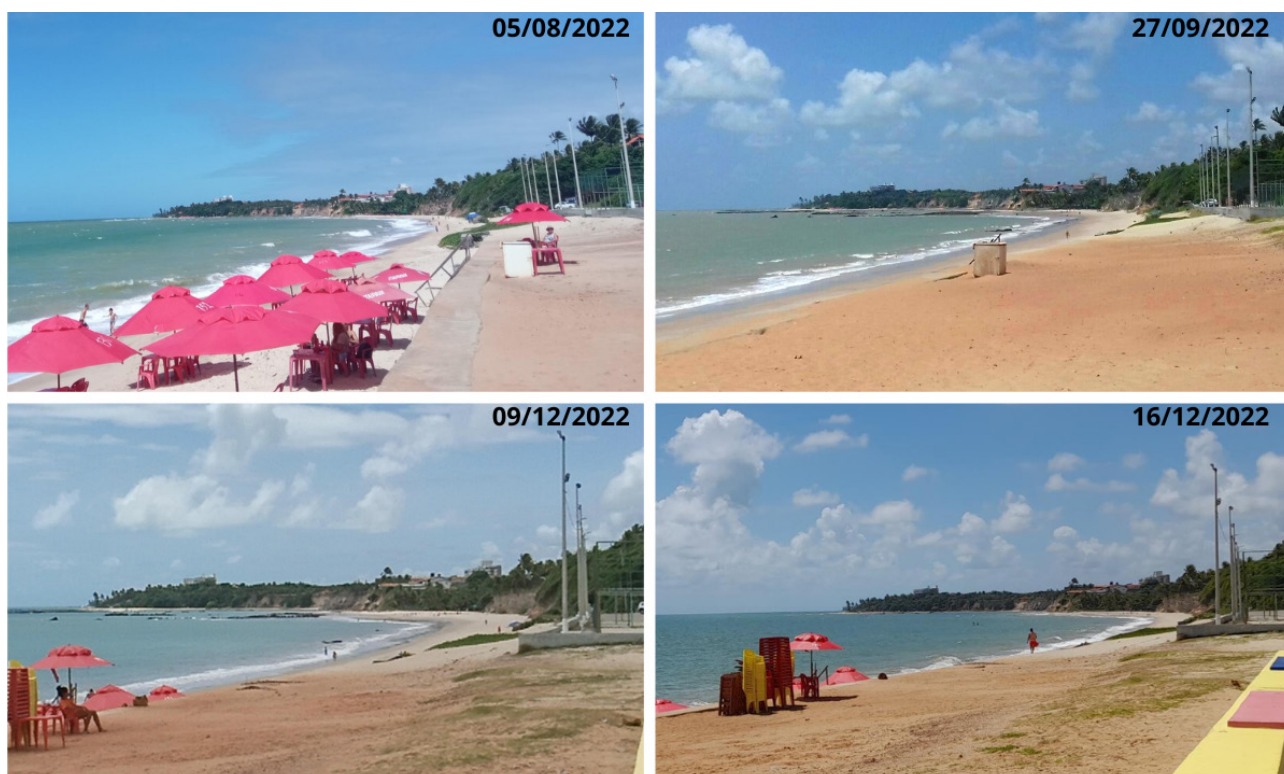
O ponto de observação localiza-se na praça do mar com vista para a praia de Carapibus ao fundo (Figura 4). Essa praia possui uma contenção de

**FIGURA 4:** Fotos da praia de Jacumã tiradas na praça do mar. Ao fundo fica a praia de Carapibus. Autodescrição: foto faixa de areia de praia e variação da linha de maré.

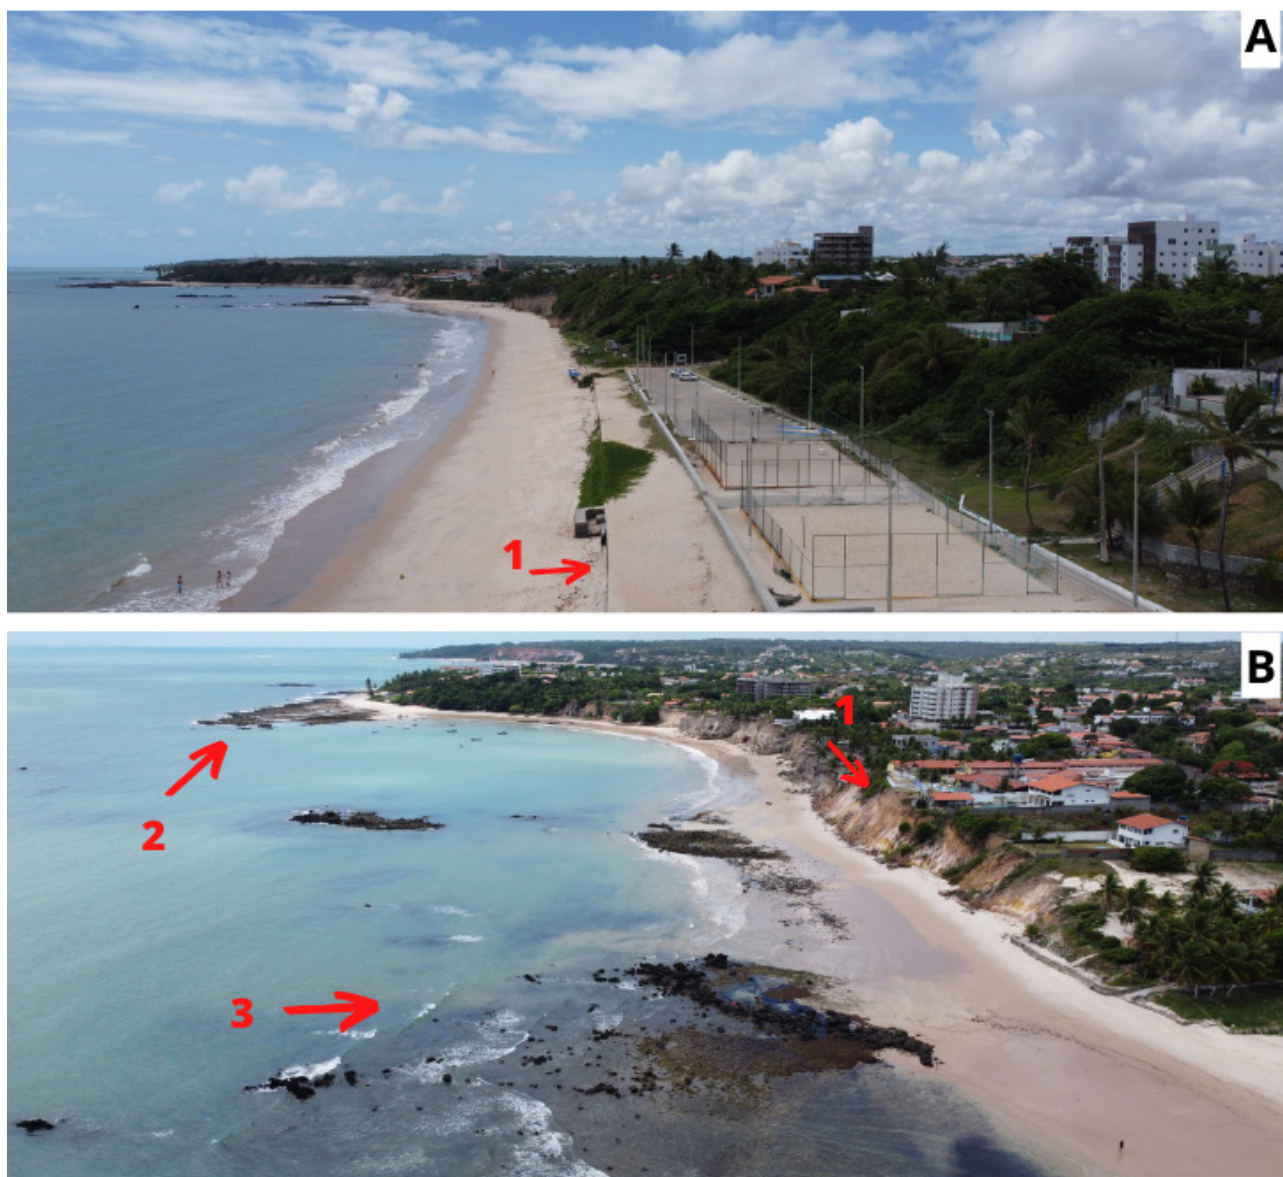
concreto que barra a maré e impede o mar de chegar na área da praça (Figura 5). No fundo da imagem à esquerda há a presença de um afloramento de rocha calcária (*beachrocks*) da Formação Maria Farinha, este afloramento é totalmente encoberto na maré alta como observado na figura 4, no dia 16/12/2022, segundo as cientistas cidadãs, essa área ocorre deslizamento das falésias, isso se deve ao fato de serem dunas ativas e devido a ocupação humana muito próxima de sua margem (Fig.4).

**FIGURA 5:** Imagens aéreas (drone) da praia de Jacumã e Carapibus. A) Praia de Jacumã, praça do mar à esquerda 1- contenção de concreto; B) Praia de Carapibus 1- Ocupação humana nas margens da falésia, 2 e 3 - afloramento calcário (*beachrocks*). Autodescrição: fotos aéreas de praias sinalizando erosão costeira

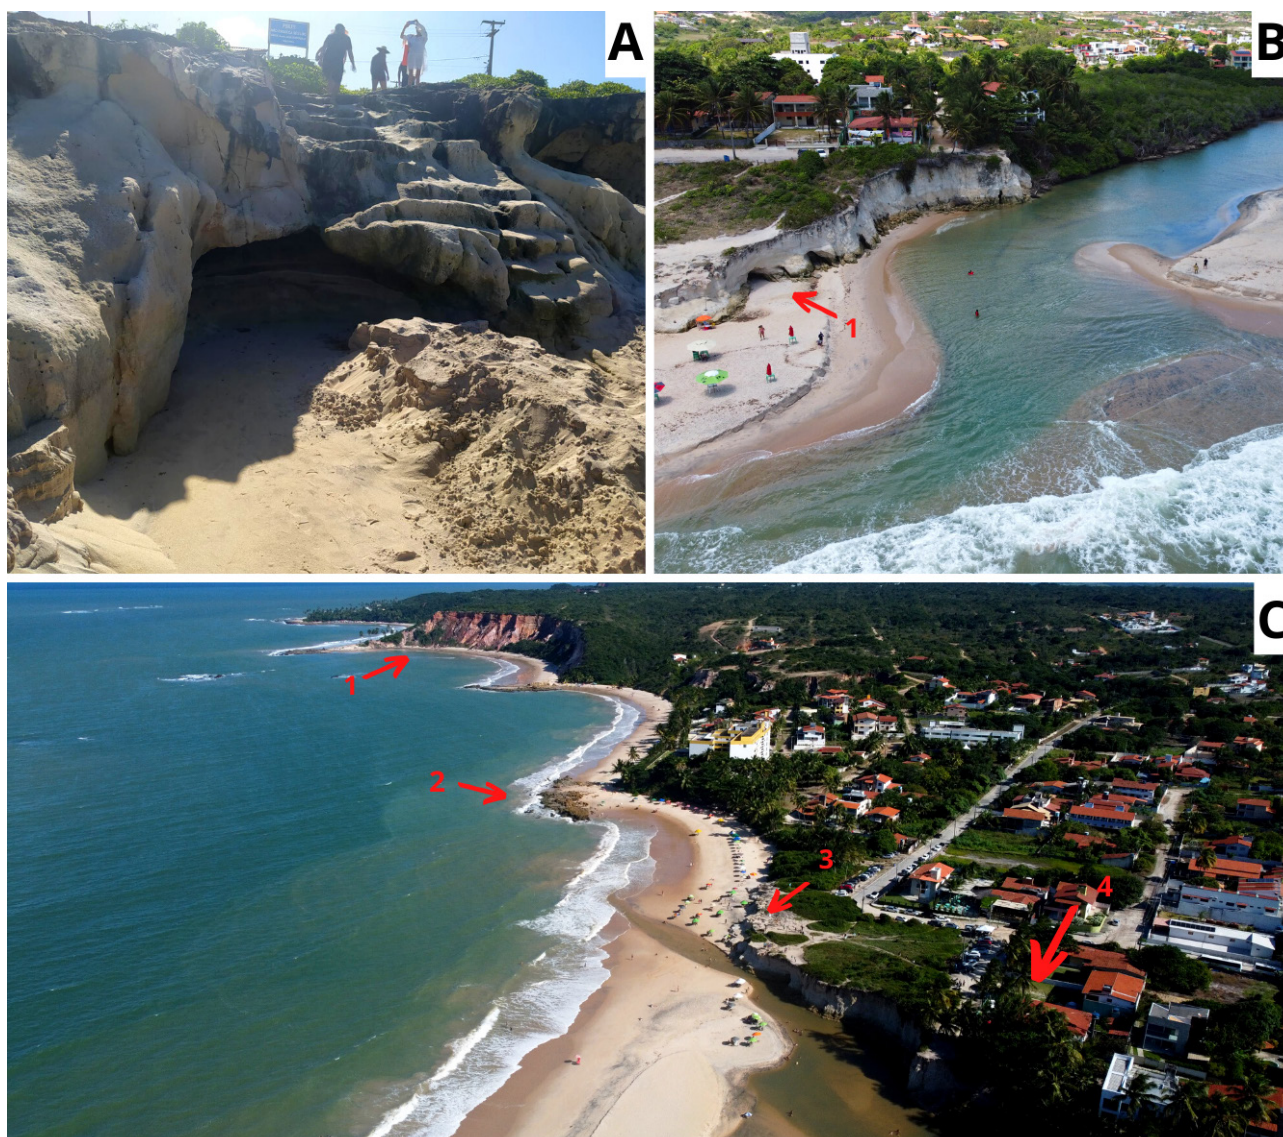
é possível observar terraços marinhos pleistocênicos e paleodunas. Esses terraços foram formados quando o nível relativo do mar esteve acima do atual, em  $8 \pm 2$  metros, denominado de Transgressão Cananéia, que ocorreu por volta de 120.000 A.P. - Antes do Presente (Suguio e Martin, 1978). Este terraço pode ser classificado como frágil por ser de origem sedimentar e vulnerável por estar em um local onde sofre constante erosão tanto por causas naturais quanto causas antrópicas. A escada que aparece nas imagens da Figura 6, foi construída no próprio terraço e uma cavidade se formou na parte inferior por conta da alta maré.

**FIGURA 6:** Detalhes da praia de Tabatinga II. A) Erosão por ação antrópica, com a construção de uma escada na própria rocha e por causa natural, formando uma cavidade na parte inferior do terraço; B) Foto aérea do terraço de frente 1- detalhe para erosão que se forma cavidades na parte inferior do terraço e a livre circulação de pessoas na superfície; C) Foto aérea da praia 1- falésias ativas, 2- afloramento de rocha calcária, 3- ponto de observação, 4- ocupação humana sobre o terraço, muito próxima da escarpa. Autodescrição: fotos aéreas de praias sinalizando erosão costeira.

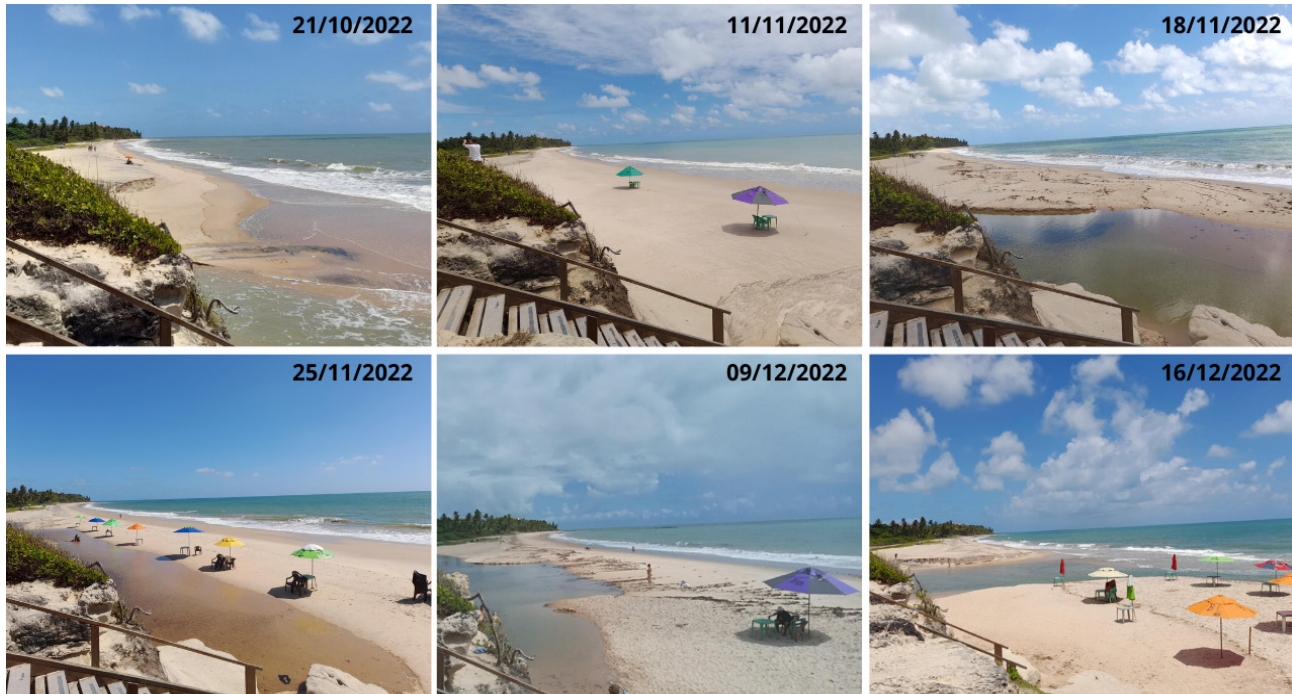
Do lado esquerdo da praia, sentido norte (Figura 7), observa-se o canal de maré que interliga o rio com o mar e que, em determinados períodos, ele se fecha formando um maceió, um tipo de formação típico da região, que ocorre normalmente em rios de pequeno porte com nascentes em platôs costeiros sedimentares e possui caudal suficiente na maré baixa para alcançar a barra da foz com o mar, gerando uma zona intermediária lacustre temporária. O monitoramento dessas mudanças é interessante para

saber o tipo de interação que ocorre nesse ambiente e entender quais as dinâmicas que fazem com que esse canal mude as direções de sua vazão. Pode-se observar que na foto do dia 21/10, 18/11 e 25/11 o canal está com sua vazão lateral, rente ao terraço marinho, já no dia 16/12 a vazão do canal muda a direção e formam-se escarpas o que indica um forte fluxo de água que erodiu essa área.

**FIGURA 7:** Linha do tempo da praia de Tabatinga II face norte. Observam-se as mudanças de direção do canal de maré. Autodescrição: fotos de variação da linha da maré em praia.

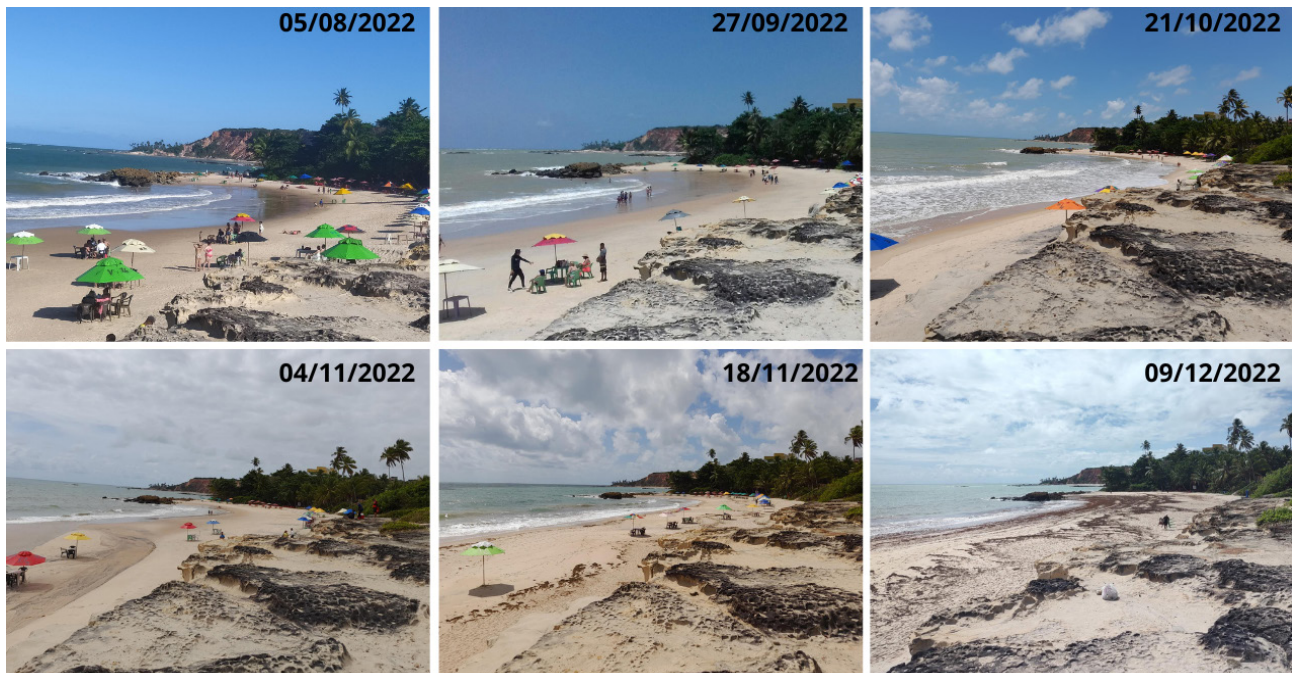
A face sul da praia (Figura 8), é possível observar parte do terraço marinho, no centro das imagens

há um afloramento de rocha calcária (*beachrock*) da Formação Maria Farinha (Furrier, 2007) e ao fundo falésias da outra porção da praia. Apesar de não haver

mudanças perceptíveis, além da variação da maré, essa área possui diversos elementos da paisagem importantes a serem monitorados.

**FIGURA 8:** Linha do tempo da praia de Tabatinga II, face sul. Observa-se parte do terraço marinho na parte inferior das imagens e no centro da imagem observam-se rochas calcárias da Formação Maria Farinha. Ao fundo das imagens parte das falésias ativas da outra porção da praia. Autodescrição: fotos de variação da linha da maré em praia

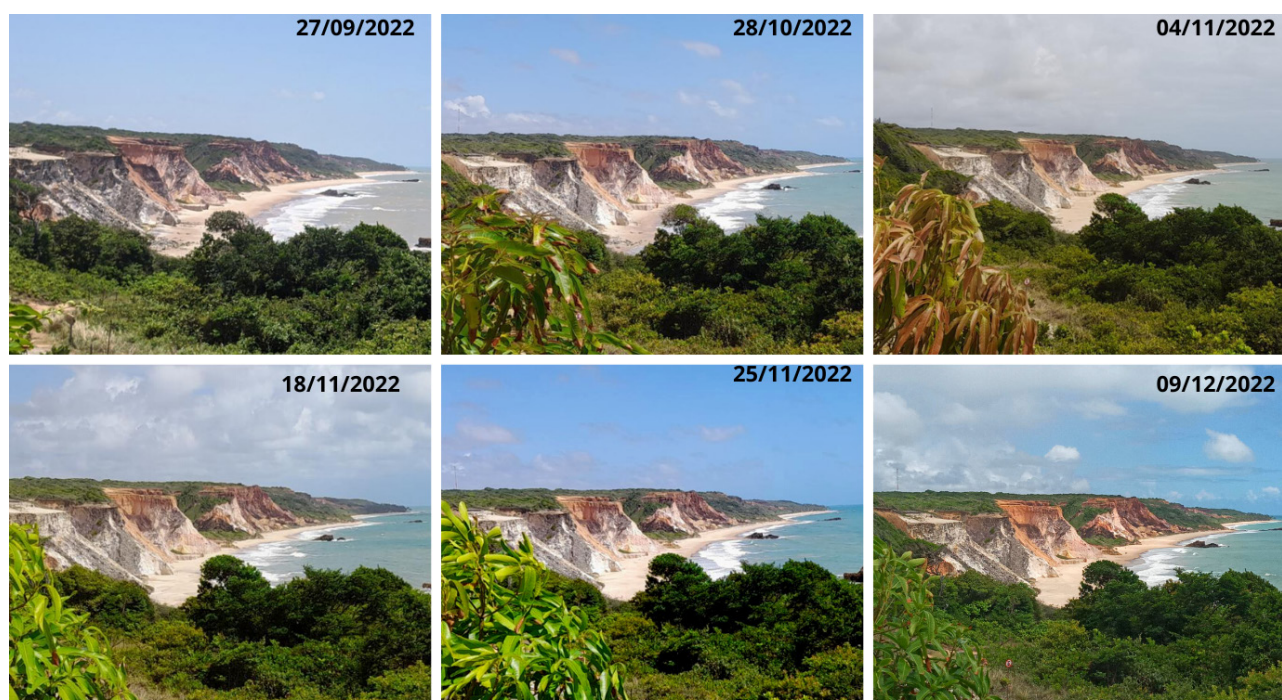
Nas imagens da Figura 9, a praia não aparenta mudanças perceptíveis nos meses de monitoramento. Através das imagens aéreas feitas por drone pode-se observar uma voçoroca presente nessa praia que não dá para identificar pelas fotos capturadas pelo aplicativo.

**FIGURA 9:** Praia da Arapuca, não aparenta mudanças perceptíveis. Autodescrição: fotos paisagem de praia
